February 2008 Newsletter

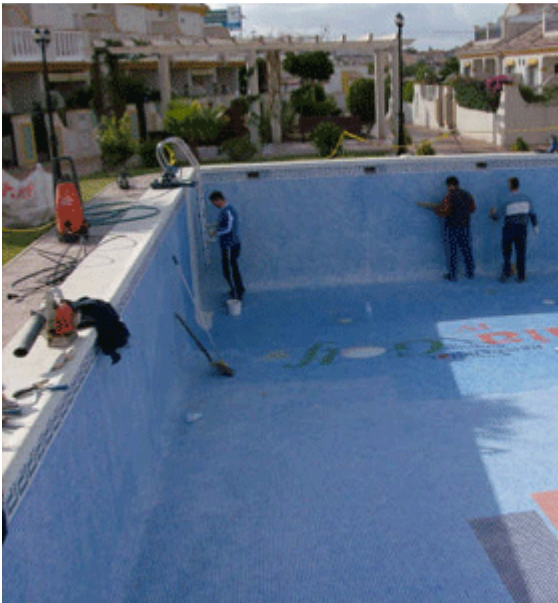
Picture 1

Picture 1: Showing the refurbishment being carried out on the large pool

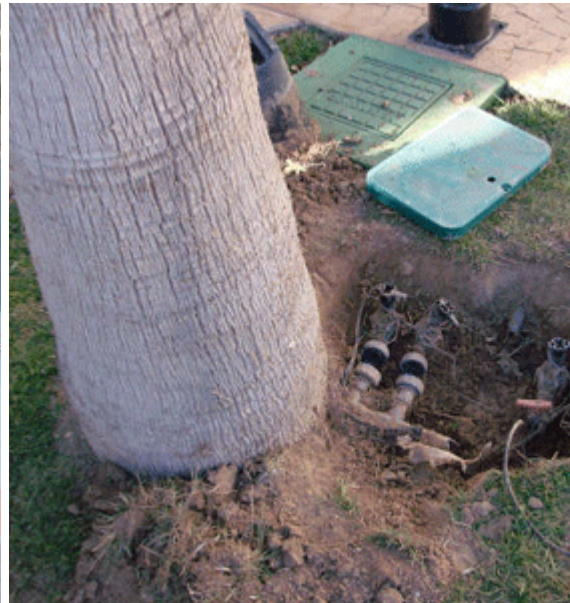
Picture 2

Picture 2: Showing the damage caused by a palm tree to the sprinkler valve system. This valve system has now been repaired and moved.

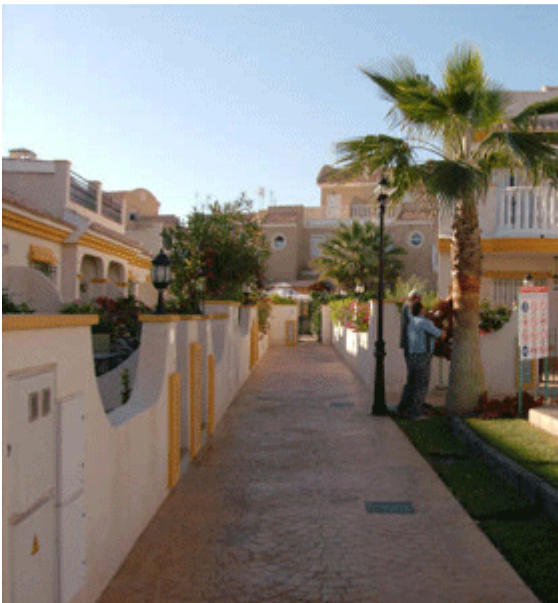
Picture 3

Picture 3: Showing the palm trees being shaved.
